Contract #: 04-0120F4Cty: SF/ALA Rte: 80 PM: 13.2/13.9File #: 69.28**WELDING INSPECTION REPORT****Resident Engineer:**Pursell, Gary**Address:** 333 Burma Road**City:** Oakland, CA 94607**Report No:** WIR-015909**Date Inspected:** 23-Jul-2010**Project Name:** SAS Superstructure**OSM Arrival Time:** 700**Prime Contractor:** American Bridge/Fluor Enterprises, a JV**OSM Departure Time:** 1900**Contractor:** Zhenhua Port Machinery Company, Ltd (ZPMC), Changxing Island **Location:** Shanghai, China**CWI Name:** Li Yang and Zhu Zhong Hai**CWI Present:** Yes No**Inspected CWI report:** Yes No N/A**Rod Oven in Use:** Yes No N/A**Electrode to specification:** Yes No N/A**Weld Procedures Followed:** Yes No N/A**Qualified Welders:** Yes No N/A**Verified Joint Fit-up:** Yes No N/A**Approved Drawings:** Yes No N/A**Approved WPS:** Yes No N/A**Delayed / Cancelled:** Yes No N/A**Bridge No:** 34-0006**Component:** OBG Trial Assembly**Summary of Items Observed:**

WELDING INSPECTION REPORT

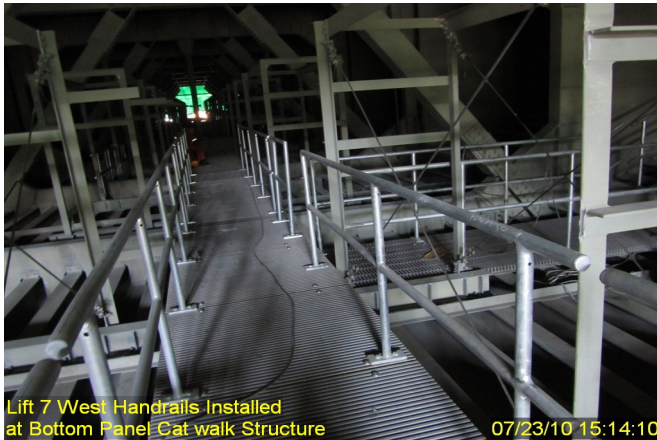
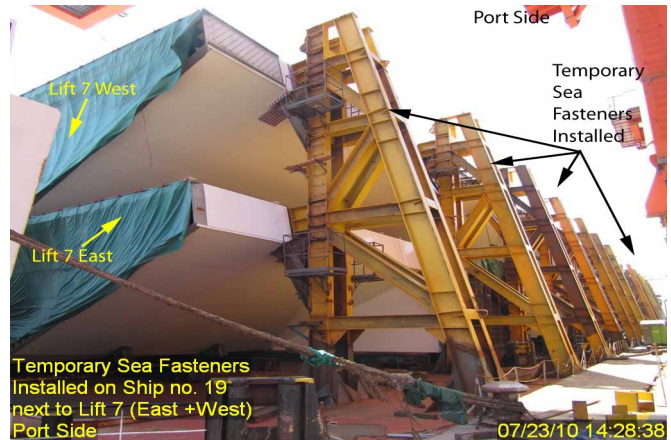
This QA Inspector witnessed the final bolt tension verification on bolts connecting the Handrail to Fiber Glass Grating between Panel Points (PP) 49 to PP 50, PP 50 to PP 51 and PP 51 to PP52 for Segment 7AW and Segment 7BW at Catwalk installed at Bottom Panel. The QA Inspector verified the bolt tension on a random basis and the results appeared to be in general compliance. The Inspection was performed against Notification No. 00435 dated July 23, 2010.

The bolt sizes used were M16 x 95 RC Lot # DHGM160017 and the final torque value established was Snug Tight.

A spanner wrench was used to verify the snug tight condition. Please reference the pictures attached for more comprehensive details.

This QA Inspector photographed the temporary Sea-fasteners at various locations on Lift 7 East and Lift 7 West from Panel Point (PP) 48 to PP 60; Lift 8 East and Lift 8 West from Panel Point 61 to PP 71 and Cross Beam # 7, Cross Beam # 8, Cross Beam # 9, Cross Beam # 10 prior to the shipment of (Voyage 4) en-route to Yerba Buena Island, California, USA. The following locations are where the photographs were taken and the photographs are available for review upon request.

Temporary Sea fasteners installed at Port side, Starboard side, Forward side and AFT side of the Segments and Cross Beams on Ship # 19 at Jetty no. 5.
